Report on
lifeboat Anna Margaretha's capsizes
November 1st 2006

Preface

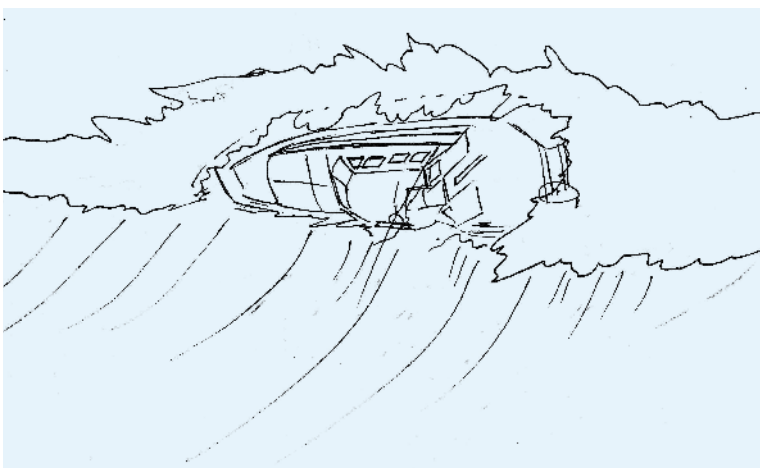
Artists impression of the first capsize.

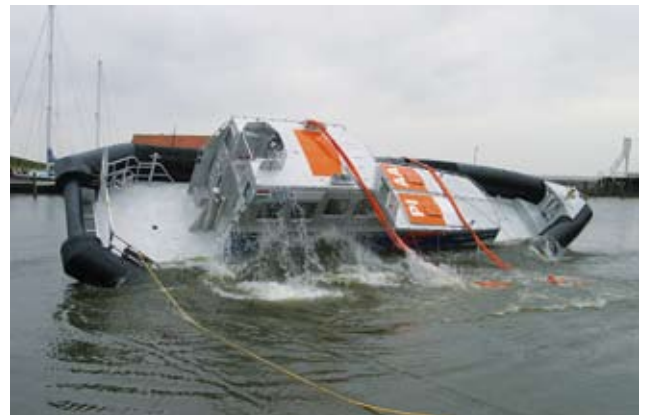
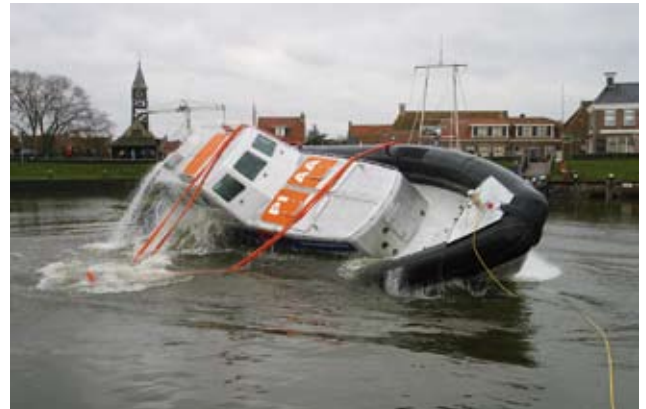
Capsize trials in the Hindeloopen harbour 2005.

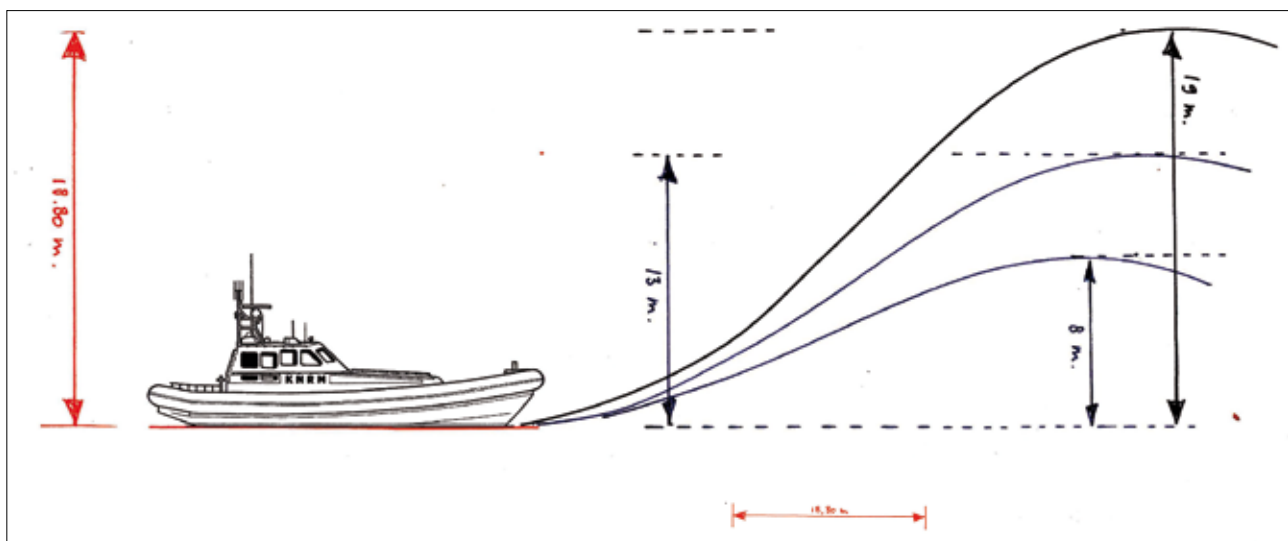
Waveheights related to the lifeboat.

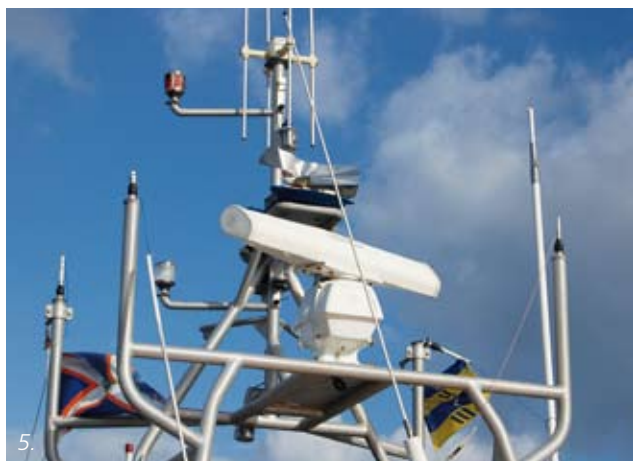
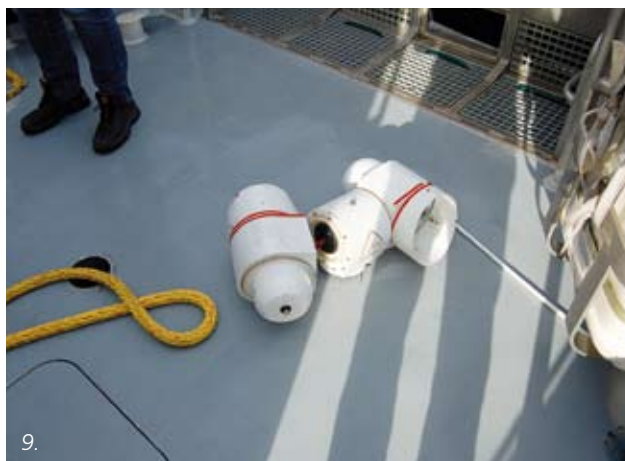
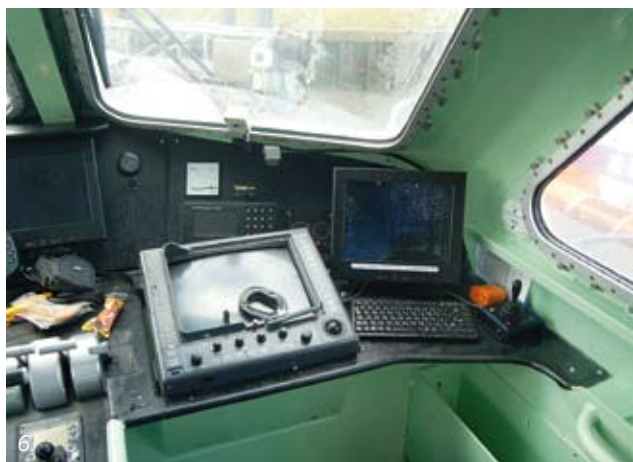
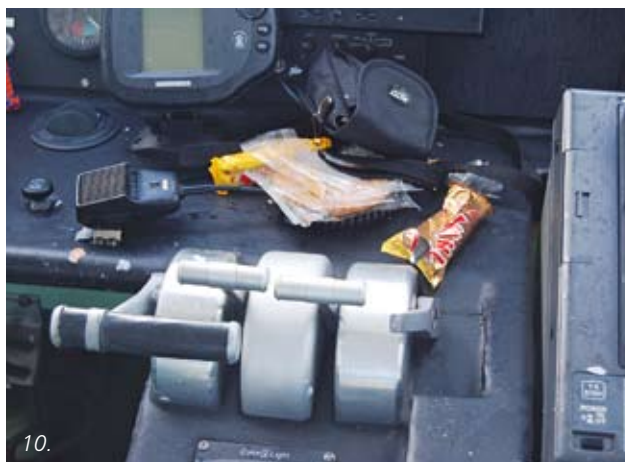
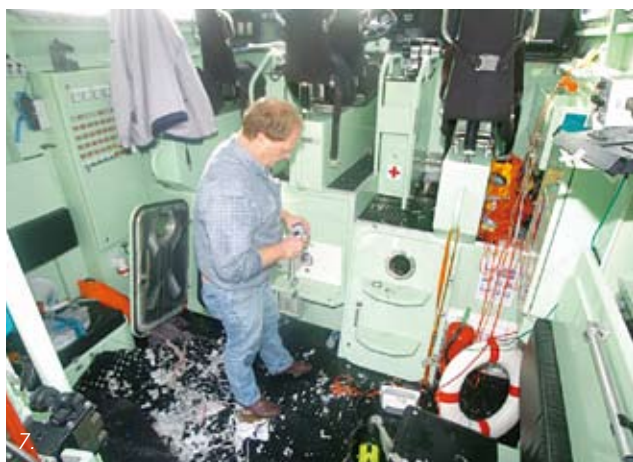
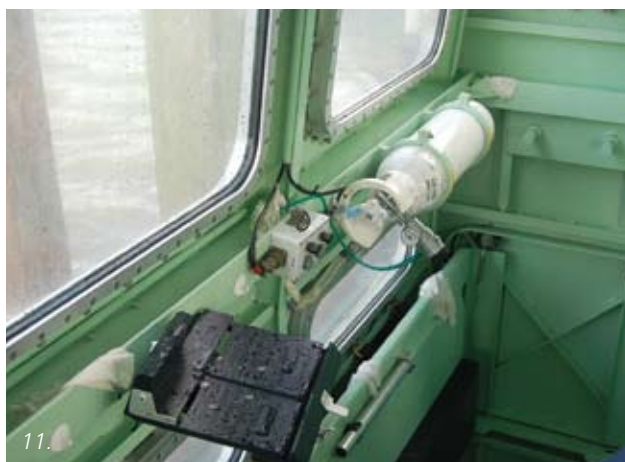
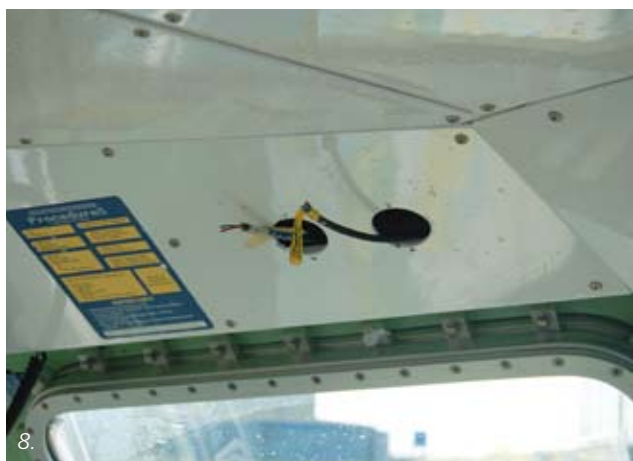
After the capsizing all electrical equipment was put out of action by some three tonnes of water sloshing around in the wheelhouse and consequent short circuits in the dashboard. Sand from the ground sea was even in the settee benches. The portable emergency VHF had gone adrift and could not be found among the litter, while the position was beyond GSM mobiles' range. Because the crew did not feel they were really in distress and did not want to trigger a lifesaving operation while they were unable to communicate, they did not activate EPIRB and START.

1. Broken aerials, missing searchlight
2. Broken overhead lining in wheelhouse
3. & 4. Debris in the wheelhouse
5. Broken aerials and radar scanners
6. Broken radar screen
7. Inspector W. Roos registers the damage
8. Cut away speakers (alarm sounders)
9. Rooftop searchlight retrieved on aft deck
10. Broken bucket handle
11. Ambulance equipment broken or bended.

The damage and general mayhem in the wheelhouse was mainly caused by water entering the evidently non-watertight dashboards through three voids below the dashboard. All cable lead-throughs below the dashboard and from it along the window frames to above need to be made watertight, which clearly will not make the dashboard watertight but at least resistant to ingress of green water. More drastic modifications seem not necessary: the main switch boards as well as the switch boxes have got wet but continued to work properly, although the push buttons to port clearly showed ingress of water. Switch boxes in a closed wheelhouse are not supposed to be watertight. Despite the soaked switch boxes, no fuses blew, although the crew switched several off because they smelt short circuits.
