Report on
lifeboat Anna Margaretha's capsizes
November 1st 2006

Preface

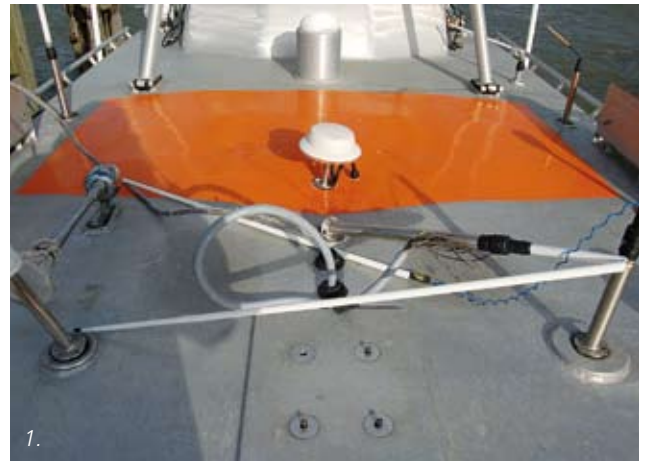
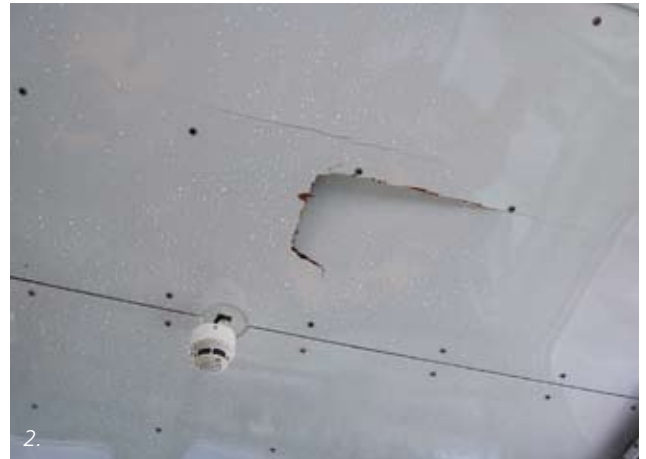
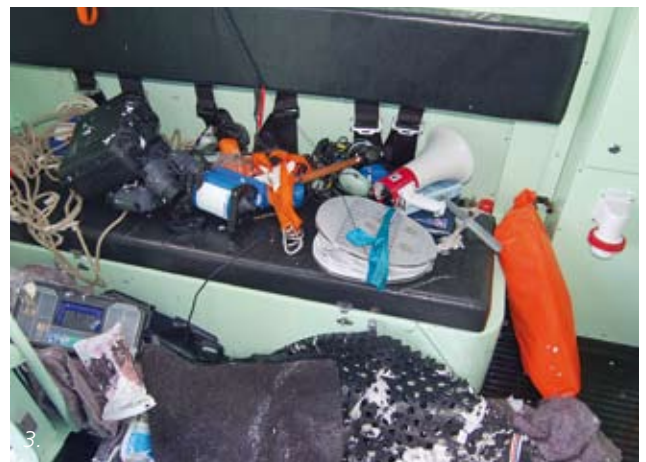
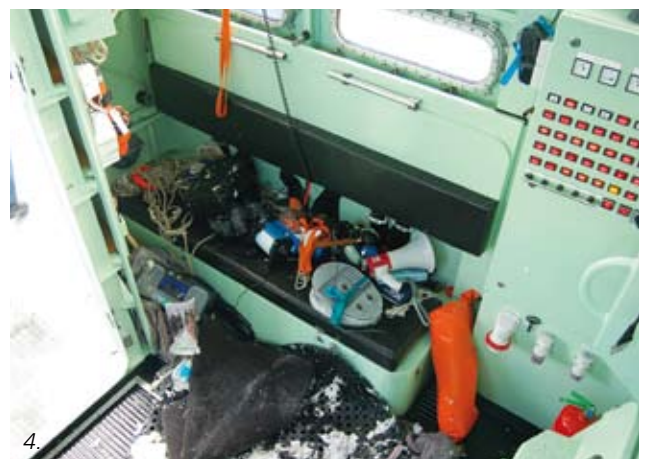
After the capsizing all electrical equipment was put out of action by some three tonnes of water sloshing around in the wheelhouse and consequent short circuits in the dashboard. Sand from the ground sea was even in the settee benches. The portable emergency VHF had gone adrift and could not be found among the litter, while the position was beyond GSM mobiles' range. Because the crew did not feel they were really in distress and did not want to trigger a lifesaving operation while they were unable to communicate, they did not activate EPIRB and START.

1. Broken aerials, missing searchlight
2. Broken overhead lining in wheelhouse
3. & 4. Debris in the wheelhouse
5. Broken aerials and radar scanners
6. Broken radar screen
7. Inspector W. Roos registers the damage
8. Cut away speakers (alarm sounders)
9. Rooftop searchlight retrieved on aft deck
10. Broken bucket handle
11. Ambulance equipment broken or bended.

The damage and general mayhem in the wheelhouse was mainly caused by water entering the evidently non-watertight dashboards through three voids below the dashboard. All cable lead-throughs below the dashboard and from it along the window frames to above need to be made watertight, which clearly will not make the dashboard watertight but at least resistant to ingress of green water. More drastic modifications seem not necessary: the main switch boards as well as the switch boxes have got wet but continued to work properly, although the push buttons to port clearly showed ingress of water. Switch boxes in a closed wheelhouse are not supposed to be watertight. Despite the soaked switch boxes, no fuses blew, although the crew switched several off because they smelt short circuits.

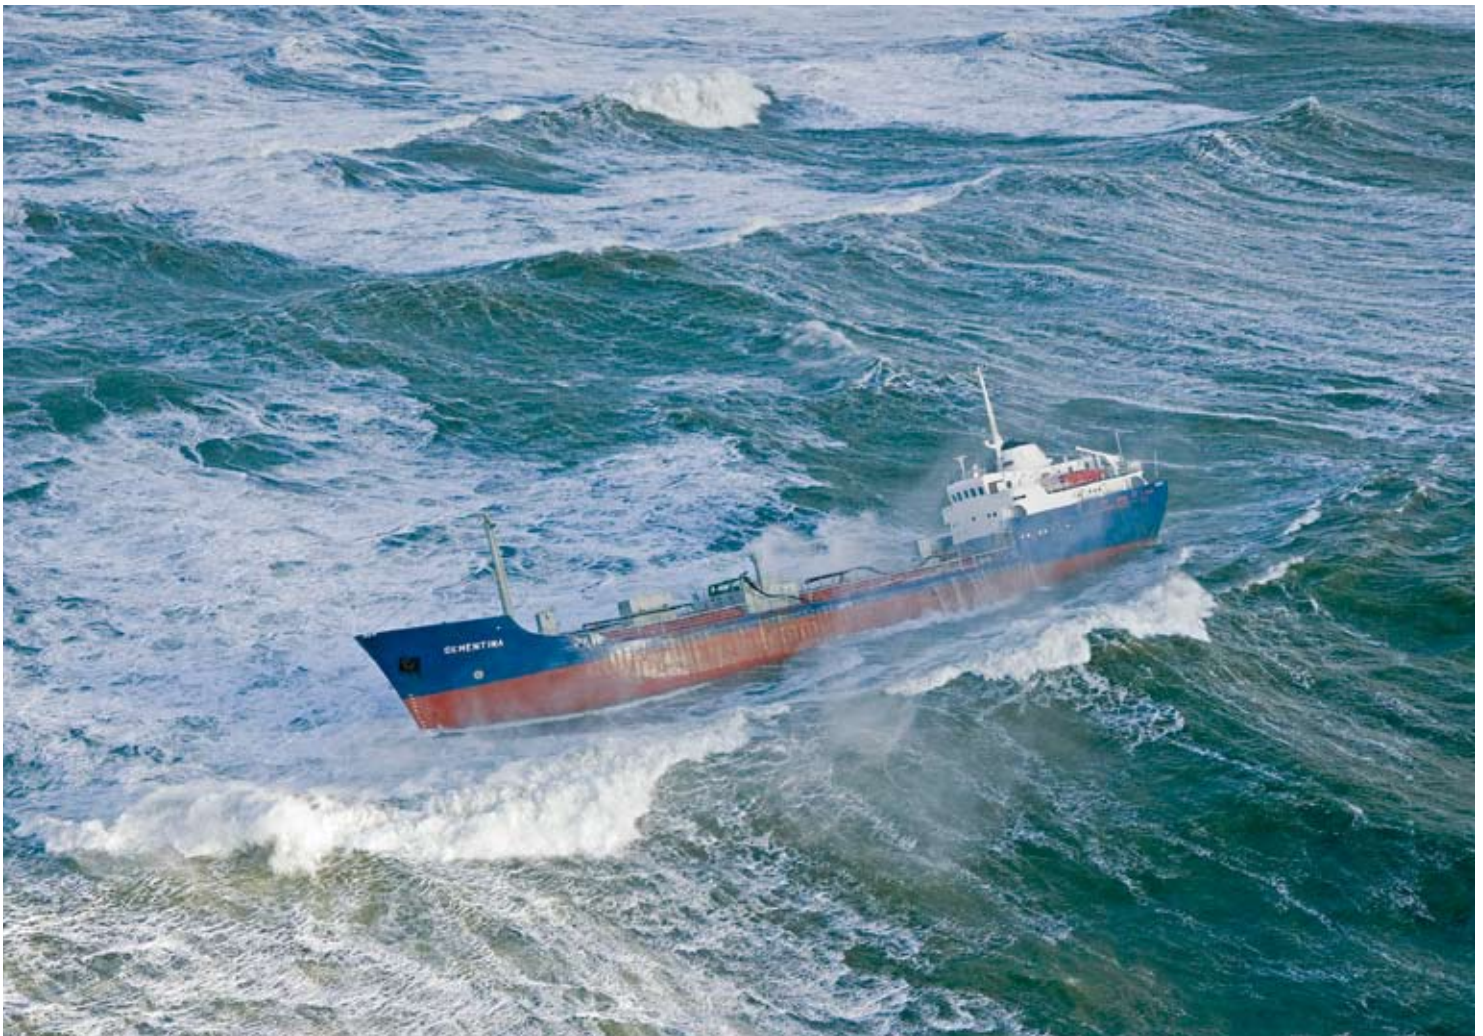
Cementina drifting in the Westereems around 09.05 hrs.

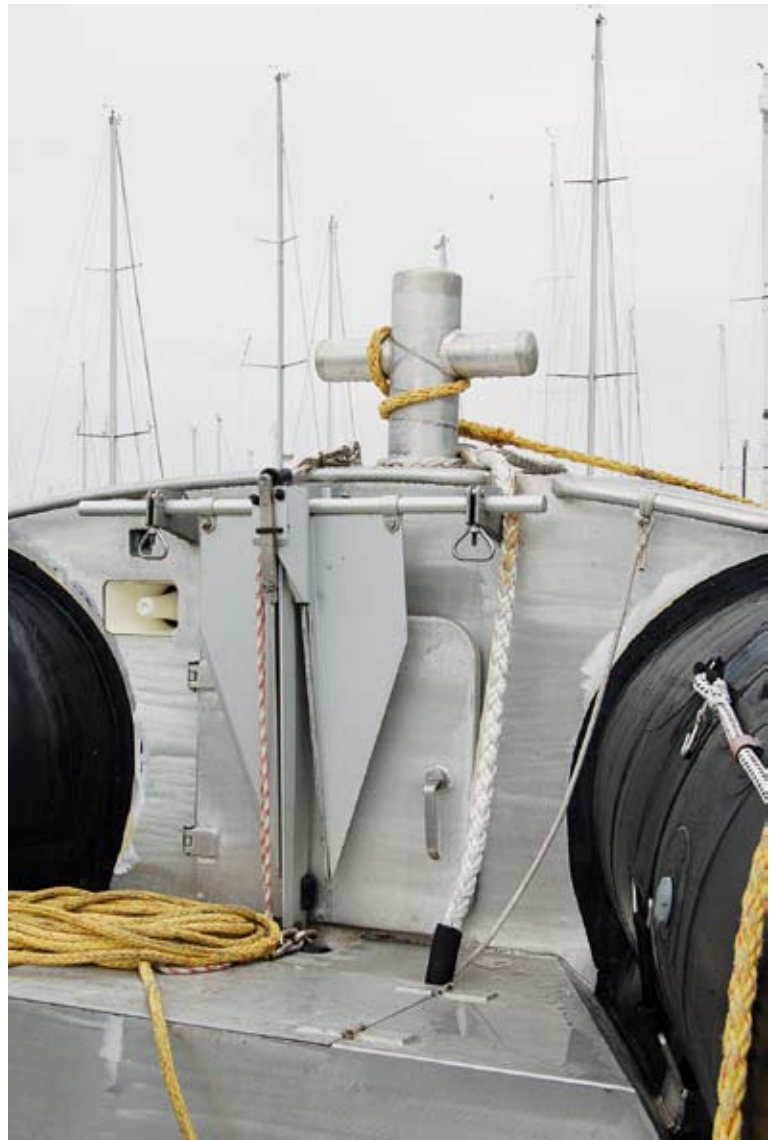
but with the lifeboat's own hawser. In preparation the cable had been taken from its drum, in a number of bights to the foredeck. After capsizing the cable had wound itself three times round the wheelhouse and had presumably caused the damage to antennae, search light and radar. If the cable would have been washed off the lifeboat it could easily have wound up in the jet, which the coxswain was actually afraid of.
